HOME INSPECTION REPORT

XXX East Ave H-13, Lancaster CA, 93535

3/19/09

Aslan Home Inspection Services

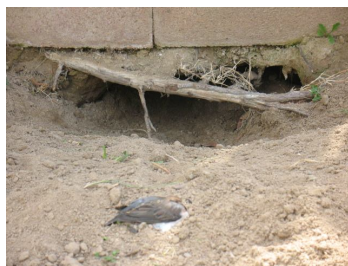
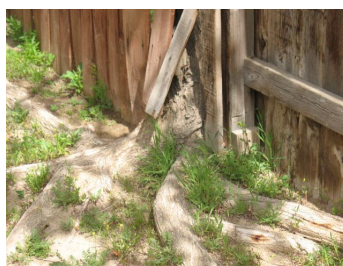
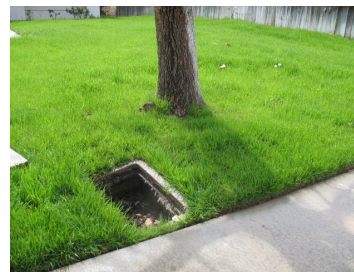
In the backyard there are ground squirrels that have dug dens under the foundation and along the back wall recommend removal of squirrels and dens.

On the East rear side of the property the neighbor's tree has encroached upon the fence and is damaging the fence recommend repair.

Recommend monitoring tree roots of tree in front yard.

Under the roof eaves there are wasp nests recommend removal.
